# THE ASSIST

July 2003

Issue No. 17

## **RSD LATCH AND PIVOT DESIGN CHANGE**

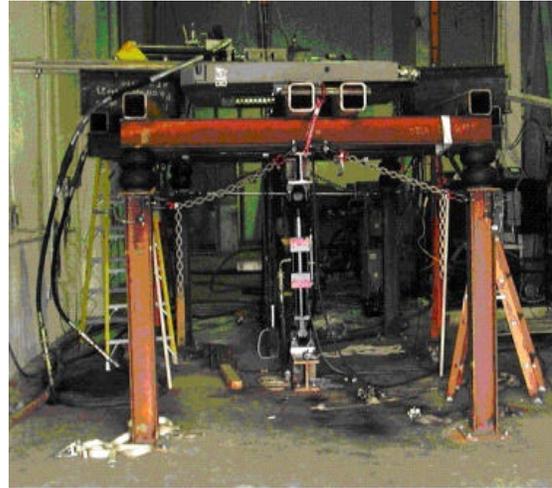
**RSD TEST SETUP LOOKING FORWARD**

Instead we took a slightly different tack. We assumed all factors were significant, and launched an effort to design a change that neutralized every factor. In doing this we could validate the change by designing a single test that combines all the factors into 3 general levels of "noise": low level stress, moderate stress, max stress. These three test levels are outlined as follows:

Low level 2 Axis vibration  
RSD Arresting Beams end gaps per LRB  
20: .005" - .010"  
RSD Arresting Beam operating cable tension: all cables @ 90 Lbs  
Latch Condition: Clean  
Probe Size: 2.730" & 2.800"  
Probe Roll: 3 Degrees  
Probe Peak Load: 5,000 lbs.  
Probe Roll Period: 3 Seconds  
Roll/Load Direction: +/- 15 Degrees to C.L.  
Probe Position in Beams: Fwd, Centered and Aft (3 positions)  
Beam Positions: Starboard Beam engaged in Cam Brakes, Port beam engaged in Cam

Low level 2 Axis vibration  
RSD Arresting Beams end gaps per LRB  
20: .025" - .030"  
RSD Arresting Beam operating cable tension: all cables @ 60 lbs  
Latch Condition: Apply small amount of dirt & grit  
Probe Size: 2.730" & 2.800"  
Probe Roll: 9 Degrees  
Probe Peak Load: 13,000 lbs.  
Probe Roll Period: 6 Seconds  
Roll/Load Direction: +/- 15 Degrees to C.L.  
Probe Position in Beams: Fwd, Centered and Aft (3 positions)  
Beam Positions: Starboard Beam engaged in Cam Brakes, Port beam engaged in Cam Brakes (ensure beams not against either side), and straightening through capture area (2 fixed positions & 1 cam brakes off for straightening)

High level 2 Axis vibration  
RSD Arresting Beams end gaps per LRB  
20: .035" - .040"  
RSD Arresting Beam operating cable tension: 40-60 lbs (different tensions each cable)  
Latch Condition: Apply small amount of dirt & grit with sea water wash  
Probe Size: 2.730" & 2.800"  
Probe Roll: 15 Degrees  
Probe Peak Load: 21,000 lbs.  
Probe Roll Period: 9 Seconds  
Roll/Load Direction: +/- 15 Degrees to C.L.  
Probe Position in Beams: Fwd, Centered and Aft (3 positions)  
Beam Positions: Starboard Beam engaged in Cam Brakes, Port beam engaged in Cam Brakes (ensure beams not against either side), and straightening through capture area (2 fixed positions & 1 cam brakes off for straightening)

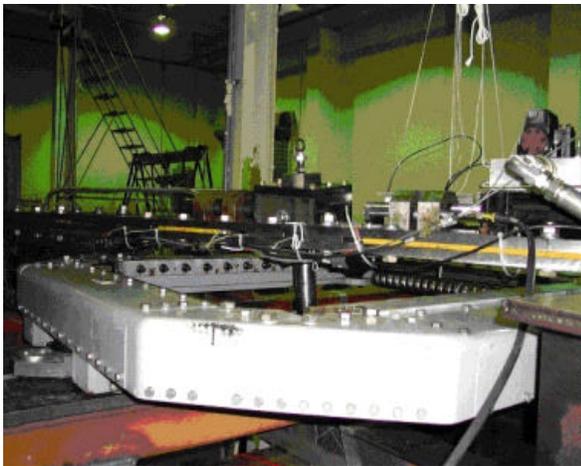
**Test RSD with Beams OPEN**

In taking this approach, we lost the ability to come away from the testing with a clear understanding of the impact of each factor, but we validated the hardness of the design change against the current baseline configuration, rapidly and cost effectively.

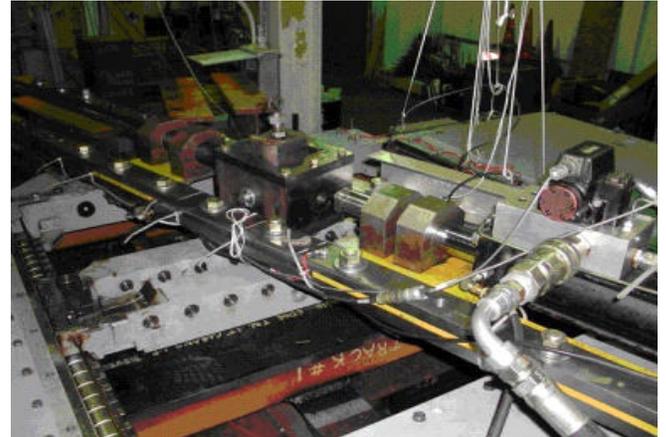
**Test RSD with Beams CLOSED**

We still learned a few things in the testing of the current baseline configuration. We learned that the forward latch repeatedly unlatched after only 2 to 4 cycles at level 1, when the probe was captured in the center of the arresting beams. When the probe was captured in the forward end of the arresting beams the forward latch held at level 1, but failed at level 2. In the aft position, both latches passed level 3. We also learned that vibration is not a significant factor because we could repeat the failures with the vibration turned off. The new latches never failed at any level, in any position.

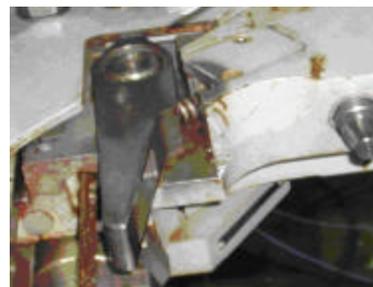
**New Latch Design**

Following the lab testing the new latch was successfully tested with live aircraft at the RAST Elevated Fixed Platform in Lakehurst, then out at sea aboard the USS ELROD.

You should start seeing the new latch out in the Fleet in late 2003/early 2004. This change will be incorporated by both overhaul facilities and by VRT simultaneously.
